# MONUMENT RECORD

Corner ID: **CICr\_S07**

## Center Quarter Corner

Section 11- T07N-R01W, 2nd P.M.

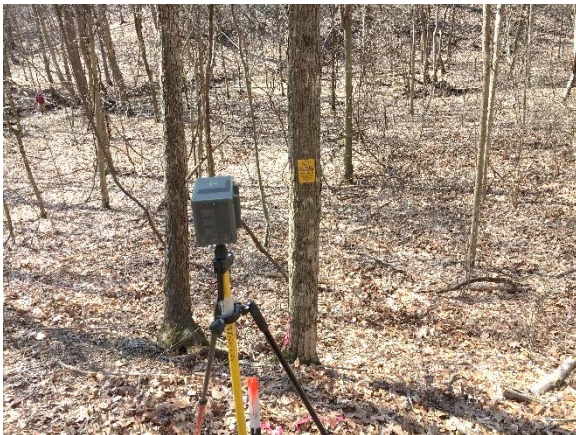
Photo Orientation & Description: Looking southwest at CICr\_S07

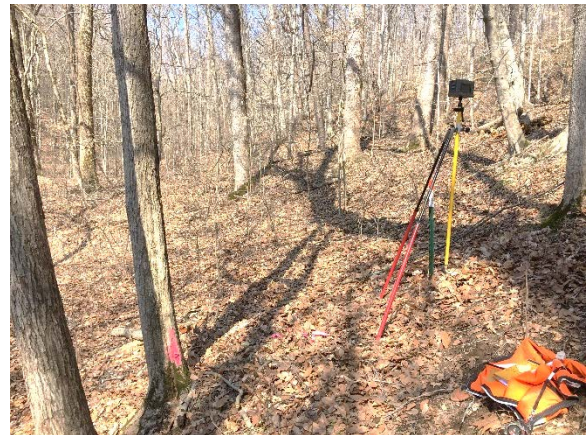
Photo Orientation & Description: Looking northwest at CICr\_S07

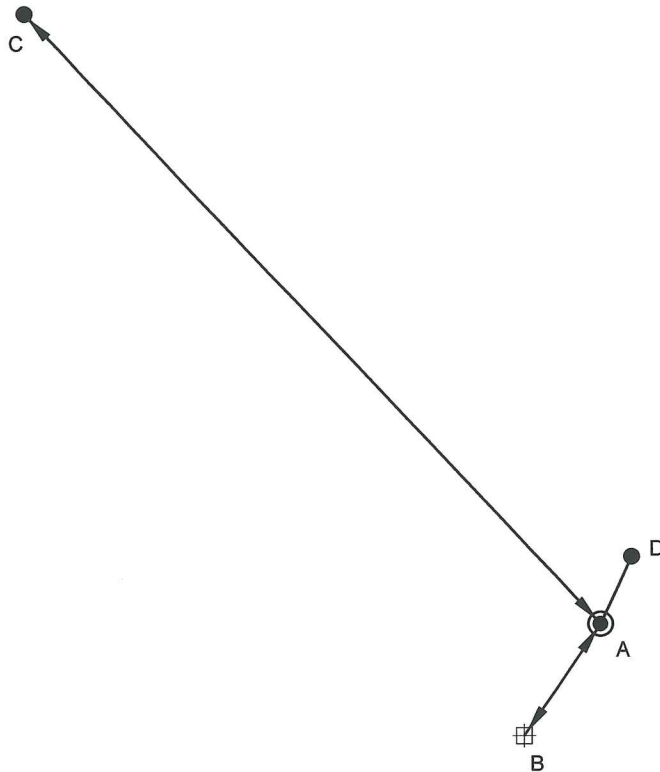
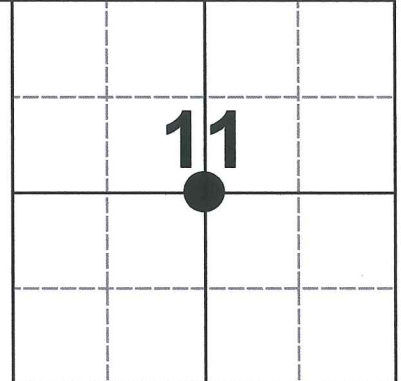
RECOVERY TIE DRAWING

**Monument Description & Remarks:** 5/8" Rebar with (chewed up) cap 4" above ground.

- A - 5/8" Rebar with cap
- B - S 35° W 7.09' to Survey Sign on 9" Sugar Maple
- C - N 43° W 43.9' to MAG nail in 23" Tulip Poplar
- D - N 25° E 3.9' to MAG nail in 8" Sugar Maple
